Shepherdstown Window Preservation Education

HISTORIC WOOD WINDOW MAINTENANCE

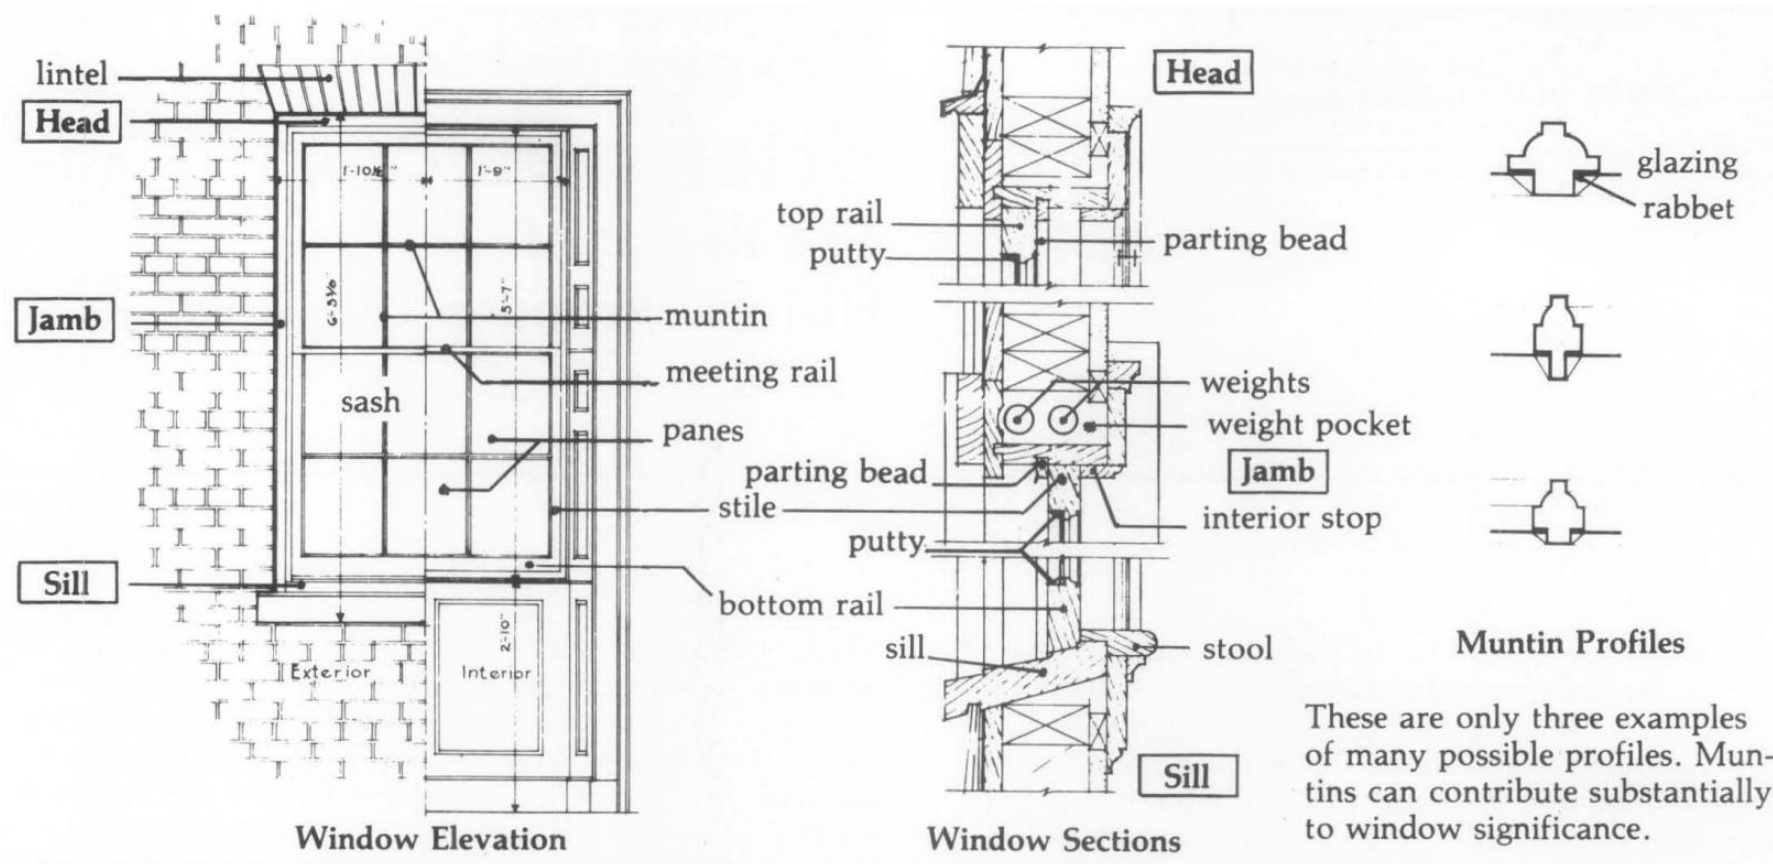
Historic Window Components

These are only three examples of many possible profiles. Muntins can contribute substantially to window significance.

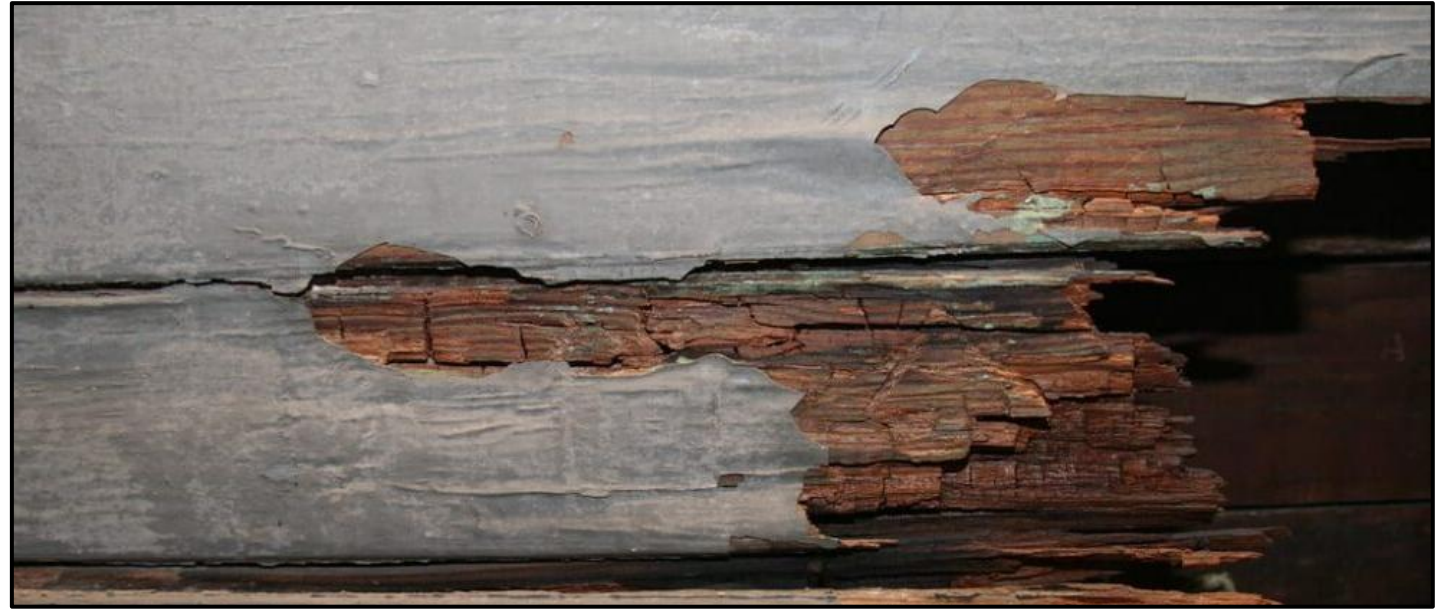
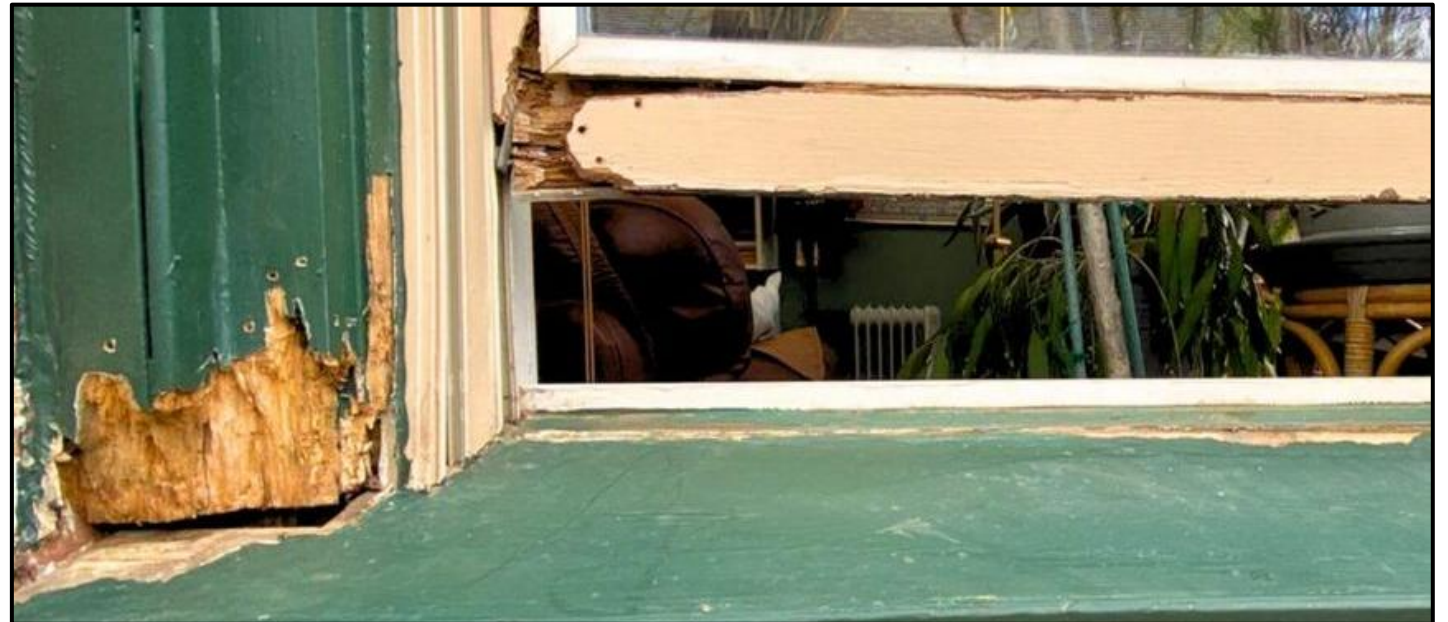
Enemy of Wood Windows Everywhere: Wood Rot

Wood rot is the natural breakdown of the wood's fibers caused by fungi. This breakdown occurs in areas with prolonged and repeated exposure to moisture. Historic windows—especially those painted shut and or poorly maintained—are particularly vulnerable to this rot

Brown Rot – Common in windows, makes wood crumbly, clumpy, and dark like chunks of tree bark

White Rot – Slower, but leaves wood spongy, pale, and fibrous, like a stringy cornstalk texture

Both thrive in wet, warm conditions. Seasonal temperature swings break up the seal of paint, allowing water to migrate into the wooden windowsills, bottom rails, and meeting rails, where the rot then breaks them down quickly.

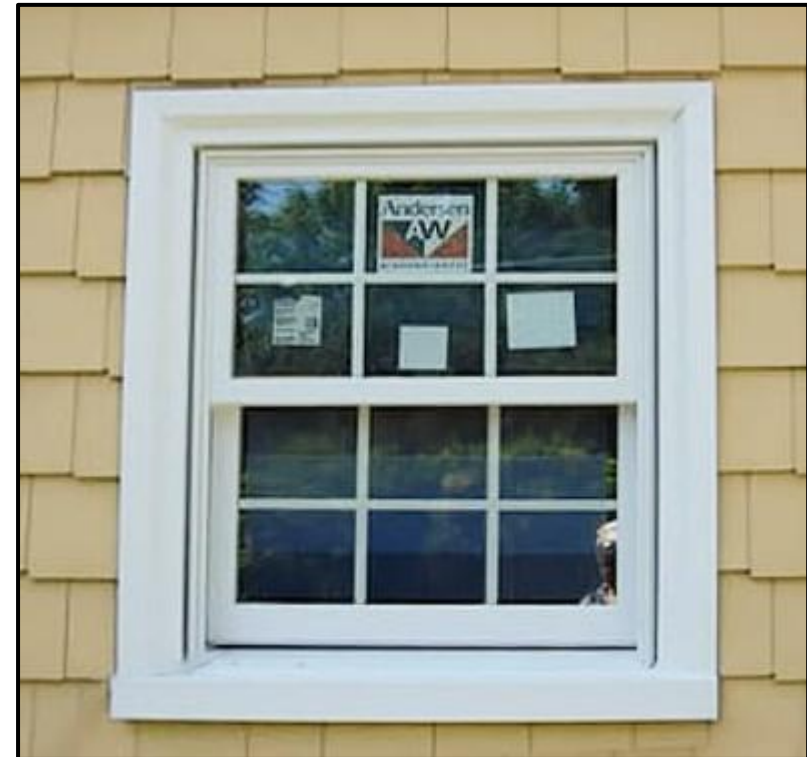
Aesthetic and Craftsmanship Issues: Modern replacements often use utilitarian profiles, flat muntins, and faux applied grids that lack the depth, shadow lines, and craftsmanship of the building's original windows. This results in a less authentic, visually inferior appearance that looks cheap and fake.

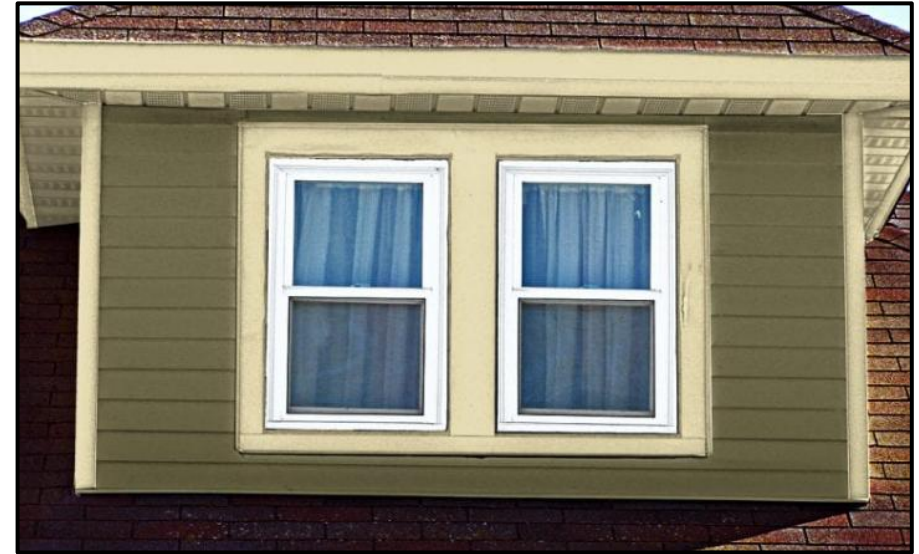
Window Component Function Diagram

A WOODEN WINDOW IS A SIMPLE SYSTEM WITH THREE COMPONENTS.

THE WOOD EXPANDS AND CONTRACTS WITH THE RISE AND FALL IN TEMPERATURE. THIS RESPONSIVENESS ALSO MEANS THAT IT IS BOTH STRONG AND FLEXIBLE ENOUGH TO ACCOMMODATE THE INFLEXIBLE GLASS.

THE GLASS, THE LEAST FLEXIBLE PART OF THE SYSTEM, LETS IN LIGHT AND KEEPS OUT WEATHER. CREATED OF SAND (OR SILICON), IT IS SEMI-VISCOUS AND ITS MOLECULES MOVE VERY SLOWLY OVER TIME.

PUTTY HOLDS THE GLASS PANE IN THE WOODEN SASH. TRADITIONALLY, PUTTY IS A MIXTURE OF LINSEED OIL AND A FINE POWDER OF CALCIUM CARBONATE THAT BONDS TO THE WOOD AND SEALS WATER OUT. IT TAKES MANY YEARS TO FULLY HARDEN, SO IT'S ABLE TO FLEX WHEN THE WOOD SHRINKS OR EXPANDS.

PUTTY IS A GOOD PARTNER TO THE WOOD, WOOD IS A GOOD PARTNER TO THE GLASS.

THOUGH BROKEN GLASS NEEDS TO BE REPLACED, THE REST OF THE SYSTEM IS REPAIRABLE, AND YEARLY CHECKS CAN MAKE SURE THE REST OF THE SYSTEM STAYS HEALTHY.

PAINT KEEPS THE WOOD PROTECTED FROM MOISTURE AND INSECTS. REPAINTING IS REQUIRED WHEN IT CRACKS OR PEELS.

PUTTY NEEDS TO BE SCRAPED AND REAPPLIED IF IT IS SEPARATING FROM THE WOOD OR CRACKED.

THE CONSTRUCTION OF WOODEN WINDOWS MOST OFTEN INCLUDES JOINERY LIKE MORTISE AND TENON SYSTEMS. SINCE THEY DON'T REQUIRE ADHESIVES, BROKEN PARTS CAN BE REPLACED, RATHER THAN REPLACING THE WHOLE WINDOW.

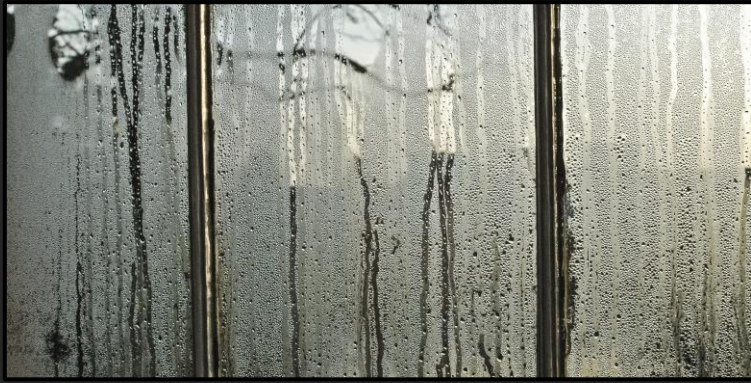
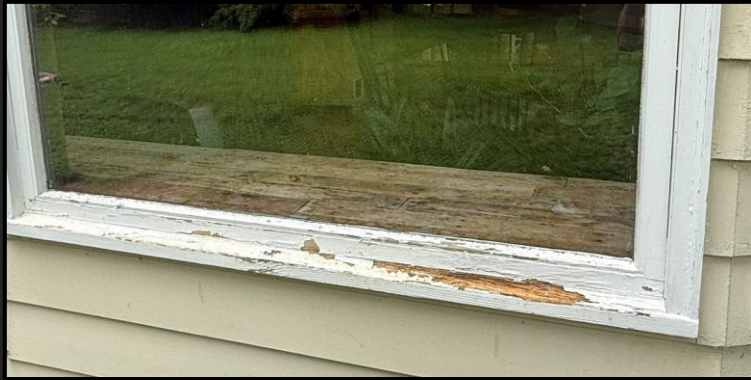
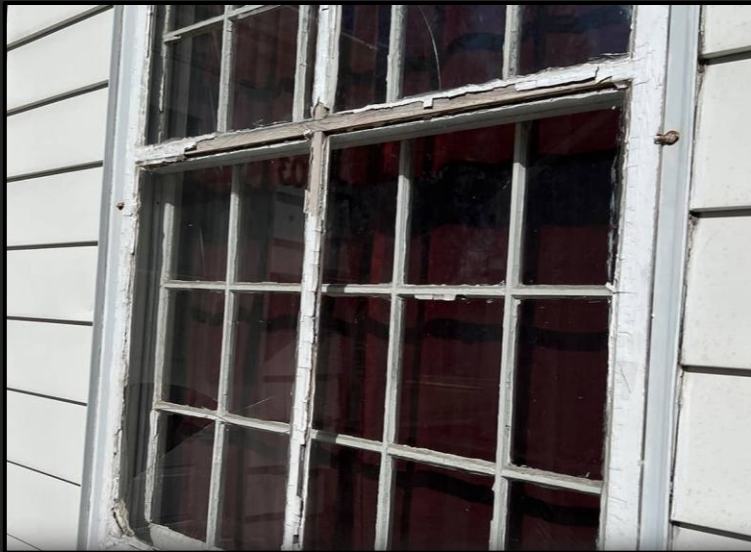
Recognizing the Signs that it's Time for Intervention

- **Musty odor:** A sign of fungal growth and moisture buildup behind the wood.
- **Water stains, leaks, or mold:** Water seeping through windows can lead to rot, structural damage, and mold growth.
- **Warped or misaligned frames:** Can compromise structural integrity and cause gaps that lead to drafts.
- **Condensation between panes:** Indicates a failed seal in double-paned windows, reducing energy efficiency.
- **Increased energy bills:** A sign that the windows are no longer providing adequate insulation.

- **Signs of failing historic wood windows include:**
- **Sticking or drafty operation:** Difficulty opening, closing, or locking windows, often due to warped sashes, damaged hardware, or failed weatherstripping.
- **Visible rot or decay:** Look for crumbly brown wood (brown rot) or spongy pale wood (white rot), especially in bottom rails, windowsills, jamb bottoms, and glazing putty edges.
- **Peeling, bubbling, or cracked paint:** Indicates moisture intrusion and potential hidden rot beneath the surface.
- **Soft or mushy spots:** Gently probe wood with a screwdriver; if it sinks easily, rot is likely present.

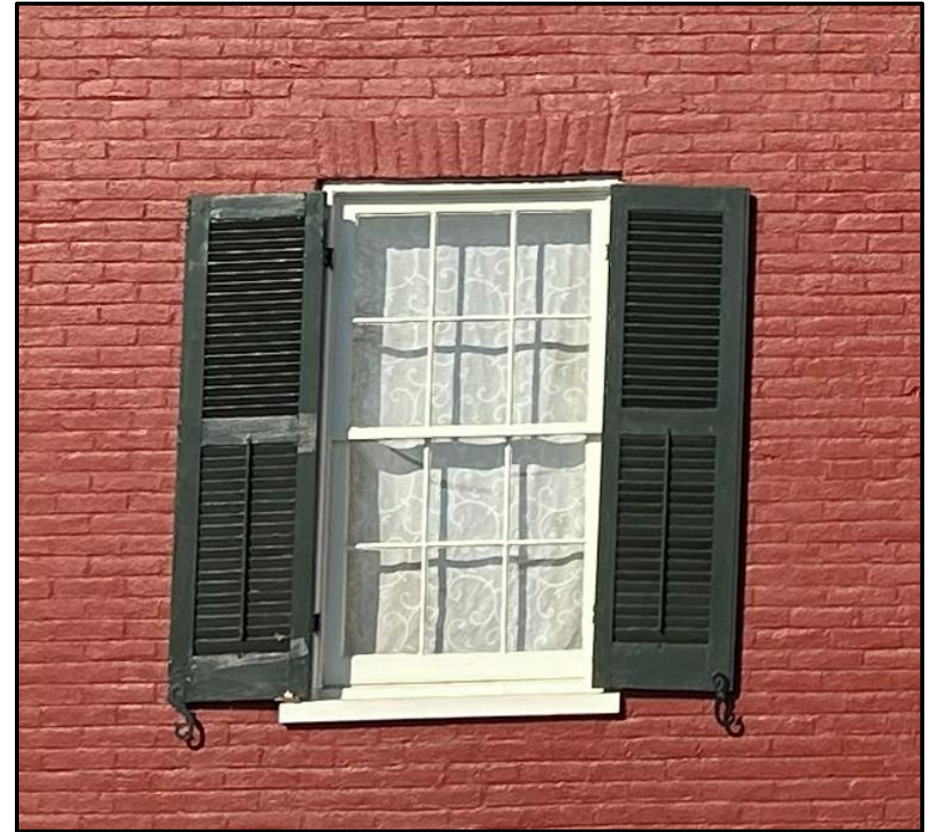
Repair Class II: Stabilization

Stabilization efforts are undertaken when portions of the wood window require intervention to prevent material destruction or material compromise.

Partially decayed wood can be waterproofed, patched, built-up, or consolidated and then painted to achieve a stable condition, seamless appearance, and extended life.

One established technique for repairing wood that is splitting, cracking, or showing signs of rot is to:

- 1) Dry the wood.
- 2) Treat decayed areas with a fungicide.
- 3) Waterproof with two or three applications of boiled linseed oil.
- 4) Fill in all cracks and holes with putty.
- 5) After a good sealing layer of putty forms, paint the surface.

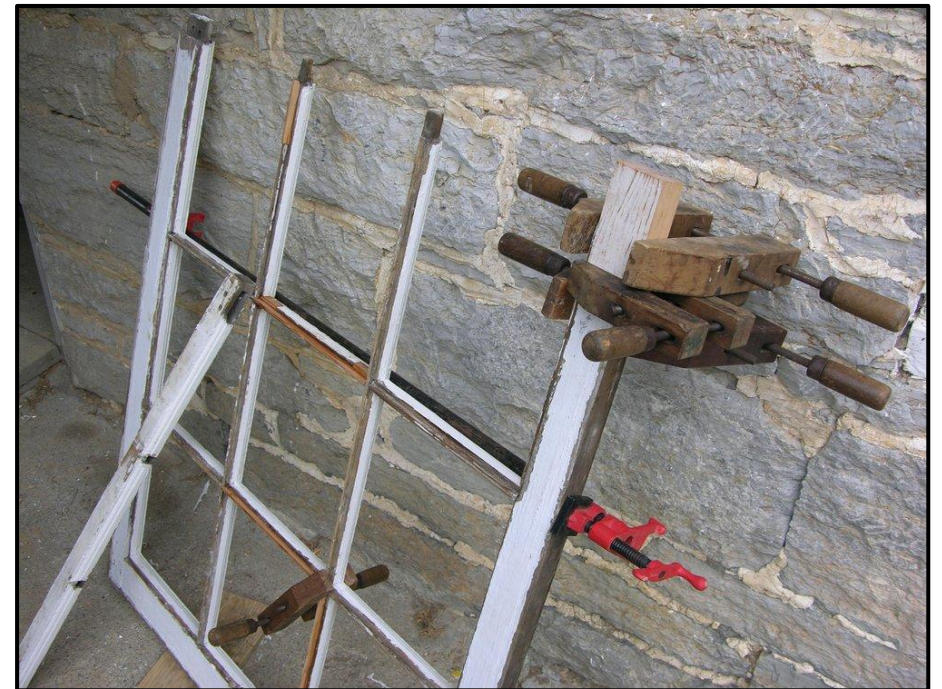
Repair Class III: Splices and Parts Replacement

Wood windows that have been left without maintenance for too long will likely require the introduction of new materials to offset deterioration. These new materials can be spliced and matched into existing historic members.

The techniques require more skill and are more expensive than any of the previously discussed alternatives. It is necessary to remove the sash and the affected parts of the frame and have the historic carpenter reproduce the damaged and missing parts. Most millwork firms can duplicate parts, such as muntins, bottom rails, or sills, which can then be incorporated back into the existing window and thus maintain as much integrity as possible.

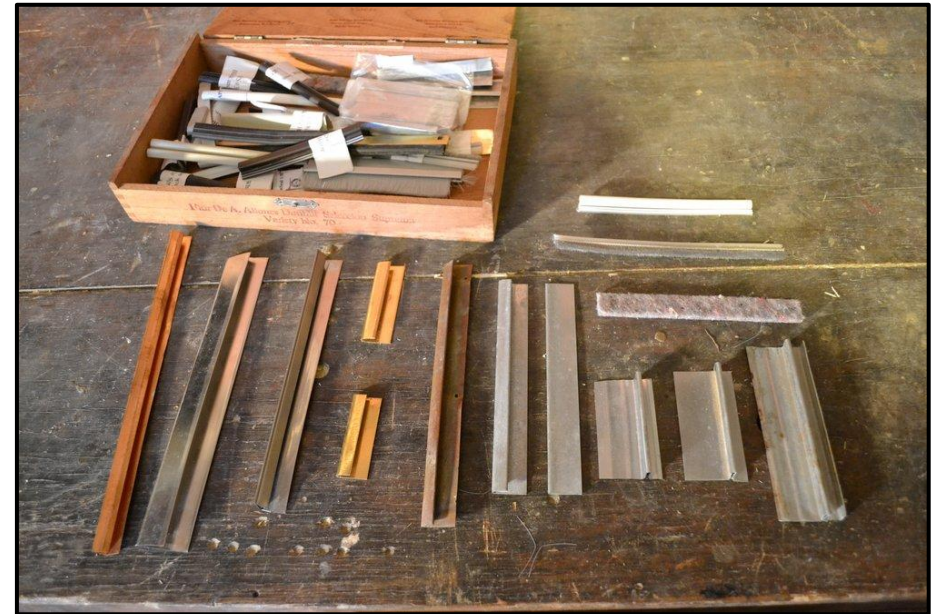
Weatherization

Any historic wood window that is maintained or repaired should be made as energy efficient as possible. The proper installation of appropriate weatherstripping reduces air infiltration.

Rolled vinyl strips may be tacked into place in appropriate locations to reduce air and temperature infiltration.

Metal strips or plastic spring strips may be used on the rails and, sometimes, in the channels between the sash and jamb.

The use of sash locks installed on the meeting rail can also ensure that the sash is kept tightly closed for more effective weatherstripping.

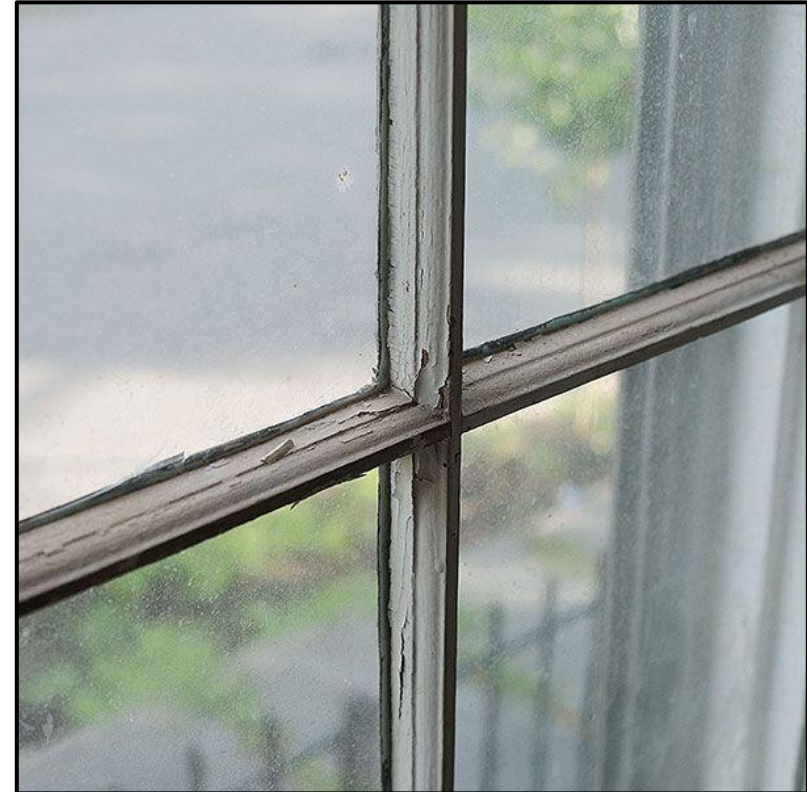
Historic Window Sash Restoration

Sash Removal and Inspection: The restoration process begins with removing the sash from the frame for inspection. The sash is inspected for damage and failing paint—especially thick, rough, or lead-based. Paint is stripped using steam or infrared heat. Failing glazing compound is assessed by sound and sight; if the glass rattles, the bed putty must be replaced.

Repair and Preparation: Damaged wood is repaired using epoxy consolidation or Dutchman repairs (wood patches) with the same species as the original. Joints are separated, repaired, reassembled, and pinned—never permanently glued. After repairs, the sash is treated with heated boiled linseed oil (BLO) to recondition the wood. A 50/50 mixture of boiled linseed oil and denatured alcohol is applied to seal dry wood and prevent oil absorption.

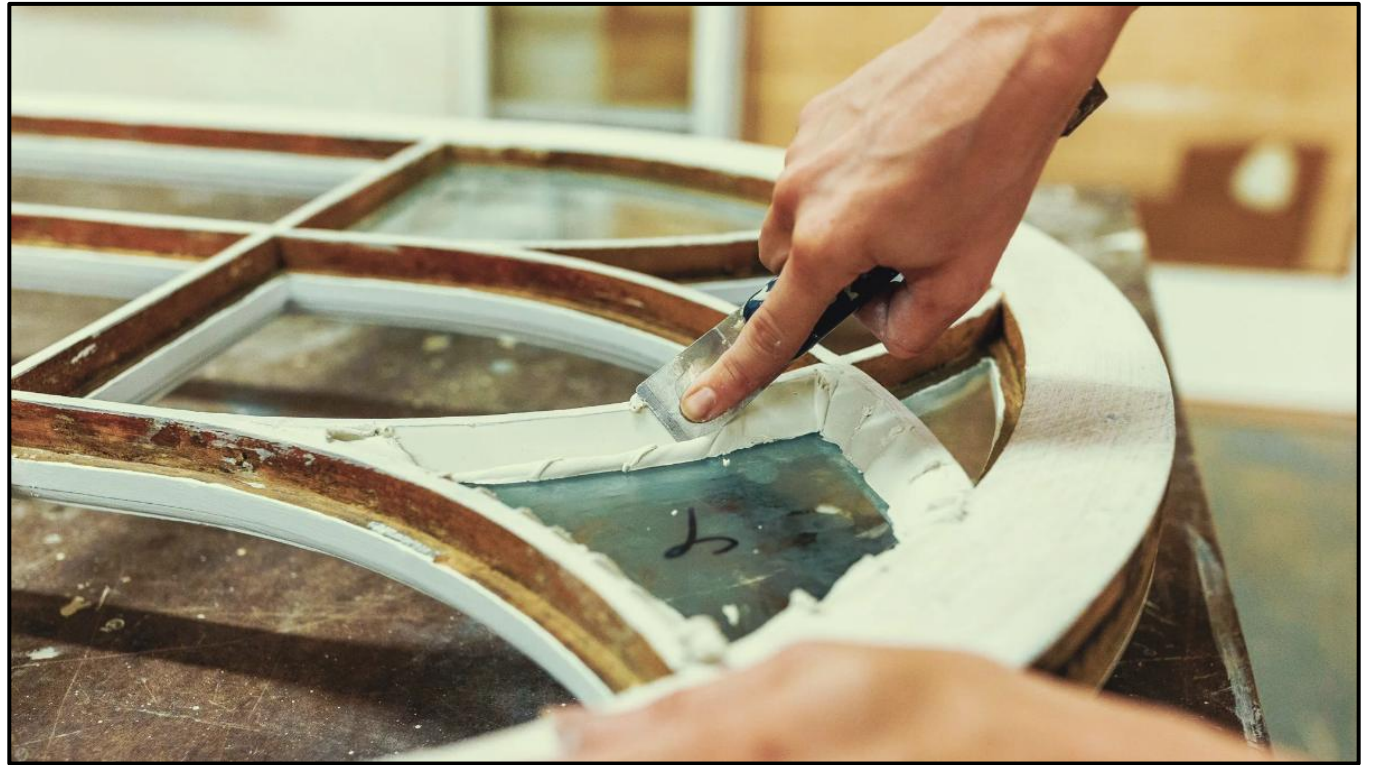
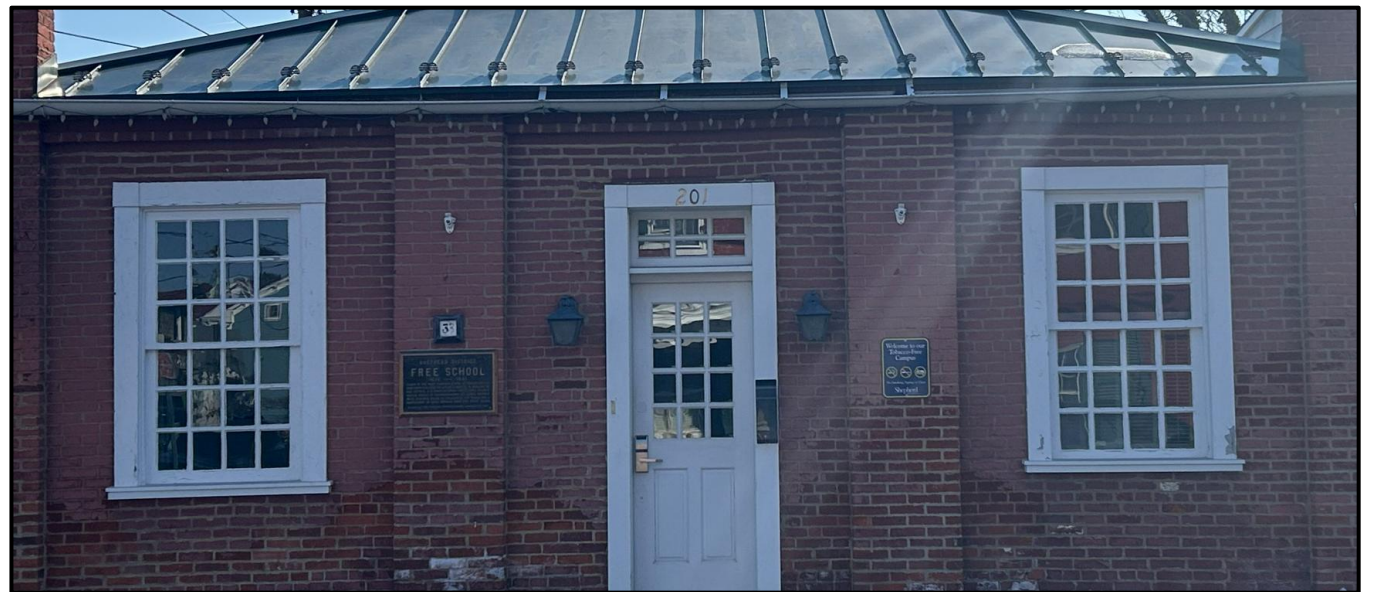
Historic Window Sash Restoration

Glazing and Sealing: The glass is reset into the sash using traditional **linseed oil-based** glazing compound. Glazing points are used to secure the glass, and the compound is smoothed with a putty knife. The compound must be allowed to cure for several days before painting to ensure adhesion and moisture resistance.

(Linseed oil is an all-natural product from the flax plant).
